**Flood Control Project Maintenance
Levee Inspections**
LMA District Cover Sheet
Spring 2018 Levee Inspection Results

Reclamation District No. 0070 Meridian

Spring 2018 Levee Inspection Results

Waterway			Bank	Unit Miles
Unit No. 01 Sutter Bypass			Right	7.92
	Spring (March - May)	Summer (June - August)	(September - November) Fall	Winter (December - February)
Unit Maintenance Rating (Fall Only)				
Date of Inspection	3/15/2018 - 3/15/2018			
DWR Inspector	Bob Duffey			
Accompanied By	Andy Duffey

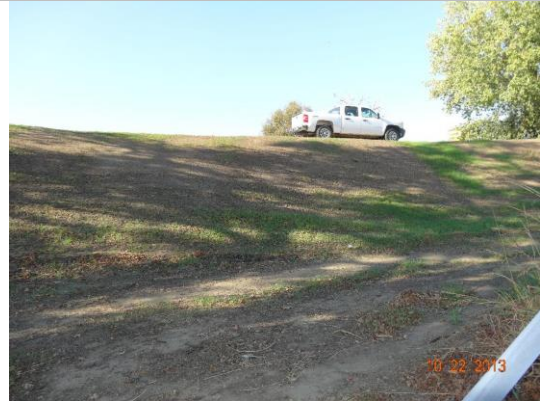
Photo 3 of 3 : UCIP_SP_2018_52618_42062.jpg

FS_ID:52618
DS_ID:21382
EP_NO: 12707
Repair Type: Urgent
Crossing Status: Found
UCIP Comments: 05/16/2018 2-foot round depression on waterward side found 4.5' from levee crown (Marty Rd). 14'x8'x3' excavation found on waterside slope to expose 14"-pipe. Evidence of internal erosion found at the bottom of excavation toward the pump. Cracks in asphalt pavement on levee crown (DWR UCIP - O.Yakimov)
11/03/2017 Crossing failed on WS and section of the levee was exposed to determine the extend of pipe damage by owner. Pipe is an up and over crossing. Crossing has been upgraded from Non-Urgent to Urgent due to pipe failure and exposed section of the levee visible on WS. (DWR UCIP - O. Magana)10/22/2013 Burrow activity noticed at this location. Crossing appurtenances have been modified. No 36-inch concrete distribution stand pipe present instead there is a concrete distribution box located at the landward toe. Also siphon breaker housing unit damage. Will need to contact owner. Need to obtain maintenance records and clarify modifications made at to crossing. Recommend having owner clear vegetation on waterward side. This crossing is referenced in the USACE Periodic Inspection as item USACE_CESPK_MRD2_2012_p_0018.

View of levee slope on landward side.

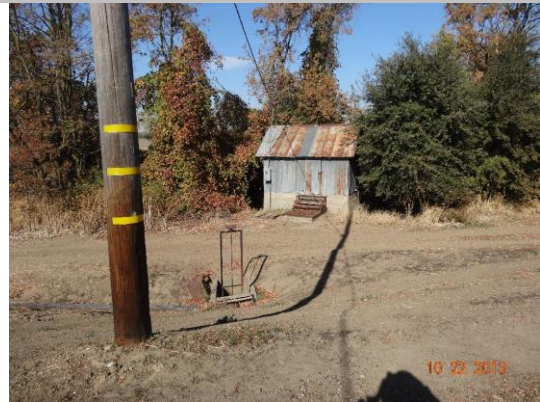
Photo 1 of 3 : UCIP_SP_2018_42923_42036.jpg

Comment Code					
Inspector Comment					
FS_ID:42923					
DS_ID:21412					
EP_NO: 1575					
Repair Type: Non-Urgent					
Crossing Status: Found					
UCIP Comments: Debris scattered on waterward side. Concrete structure on waterward side shows major cracks on the walls. Will need to notify owner. Need to obtain maintenance records to confirm integrity of pipe. This crossing is referenced in the USACE Periodic Inspection as item USACE_CESPK_MRD2_2012_p_0075.					
FIELD_STRUCT_DESC: 20-inch steel irrigation discharge pipe through the levee, 17 feet below the crown. Pump and 10-inch slide gate in a pump house on the waterside (WS). Concrete collar at the WS toe. Power pole on the WS slope. Anchor on the landside (LS) slope. Rock revetment on the WS slope. (Plans for installing an irrigation pumping plant and a 20-inch discharge pipe through the levee authorized under Permit No. 1575, 1951 - Meridian Farms Water Company). [Additional Reference(s): DWR Levee Log, 2007].

View of waterward side--appurtenances present pump house, concrete distribution box, screw gate, and power pole.

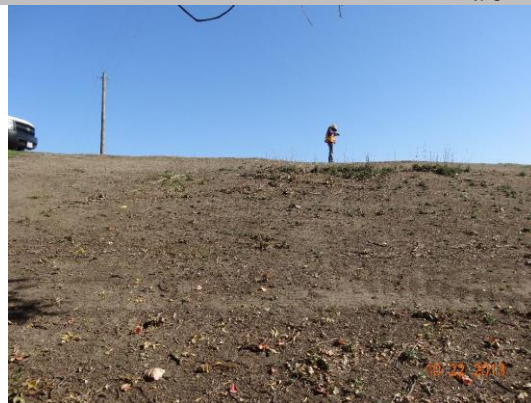
Photo 1 of 3 : UCIP_SP_2018_23885_41814.jpg

Comment Code						
Inspector Comment						
FS_ID:23885 DS_ID:21365 EP_NO: 9973 Repair Type: Non-Urgent Crossing Status: Found UCIP Comments: Cut to levee toe found on landward side. Unable to determine if crossing is being used. If crossing is no longer used by owner, the owner will need to coordinate with DWR Inspector and CVFPB to remove crossing according to Title 23 requirements. This crossing is referenced in the USACE Periodic Inspection as item USACE_CESPK_MRD2_2012_p_0099. FIELD_STRUCT_DESC: 18-inch steel irrigation discharge pipe through the levee, 18.8 feet below the crown. Slant pump on the waterside (WS). Slide gate on a gate structure on the WS. (Retention of an 18-inch steel pipe through the levee, 18.8 feet below the crown, and a slide gate authorized under Automatic Board Order (ABO) issued as Permit No. 9973, 1974 - Pearl V. Clark). [Additional Reference(s): DWR Levee Log, 2007. USACE Sacramento O&M Manual 134, June 1953, (Station 399+34)]. FS Date: 10/22/2013

View of waterward slope.

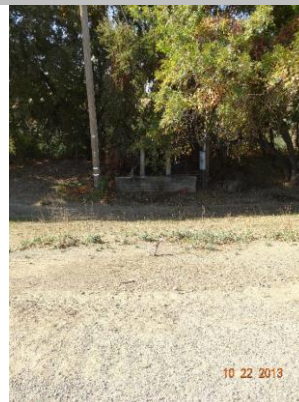
Photo 2 of 3 : UCIP_SP_2018_23885_41817.jpg

Overview of waterward slope.

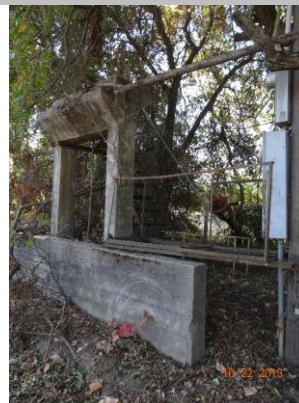
Photo 3 of 3 : UCIP_SP_2018_23885_41815.jpg

Comment Code						
Inspector Comment						
FS_ID:23885 DS_ID:21365 EP_NO: 9973 Repair Type: Non-Urgent Crossing Status: Found UCIP Comments: Cut to levee toe found on landward side. Unable to determine if crossing is being used. If crossing is no longer used by owner, the owner will need to coordinate with DWR Inspector and CVFPB to remove crossing according to Title 23 requirements. This crossing is referenced in the USACE Periodic Inspection as item USACE_CESPK_MRD2_2012_p_0099. FIELD_STRUCT_DESC: 18-inch steel irrigation discharge pipe through the levee, 18.8 feet below the crown. Slant pump on the waterside (WS). Slide gate on a gate structure on the WS. (Retention of an 18-inch steel pipe through the levee, 18.8 feet below the crown, and a slide gate authorized under Automatic Board Order (ABO) issued as Permit No. 9973, 1974 - Pearl V. Clark). [Additional Reference(s): DWR Levee Log, 2007. USACE Sacramento O&M Manual 134, June 1953, (Station 399+34)]. FS Date: 10/22/2013

Concrete structure located on waterward side with screw gate.

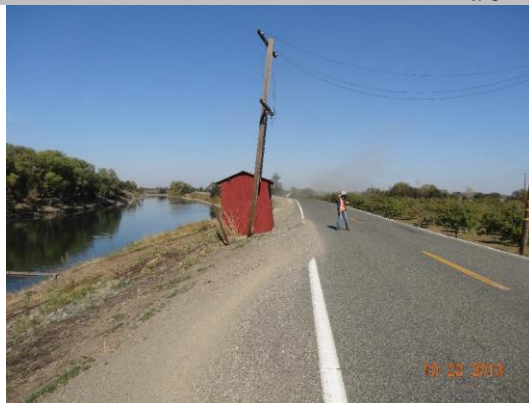
Photo 1 of 3 : UCIP_SP_2018_23888_41819.jpg

FS_ID:23888
DS_ID:21366
EP_NO: 9996
Repair Type: Non-Urgent
Crossing Status: Found
UCIP Comments: Need inside photo of the concrete distribution box located at the landward toe. Debris found on waterward slope (conduit running parallel to levee). This crossing is referenced in the USACE Periodic Inspection as item USACE_CESPK_MRD2_2012_p_0124.
FIELD_STRUCT_DESC: 12-inch steel irrigation discharge pipe through the levee, 24 feet below the crown. Gate valve in a concrete U-shaped headwall on the waterside (WS) slope. Pump and switch house on the WS shoulder. Discharge box at the landside (LS) toe. (Retention of a 12-inch steel pipe through the levee, 24 feet below the crown, a pump, a gate valve, a switch house, and a discharge box authorized under Automatic Board Order (ABO) issued as Permit No. 9996, 1974 - Chas. F. and Nora M. Reische, et al.). [Additional Reference(s): DWR Levee Log, 2007].
FS Date: 10/22/2013

View of levee crown and waterward side.

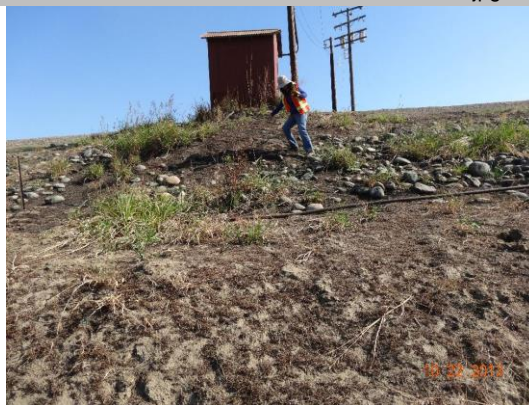
Photo 2 of 3 : UCIP_SP_2018_23888_41822.jpg

View of slope on waterward side.

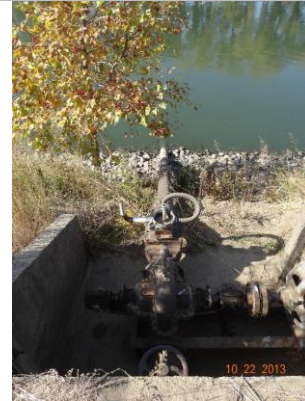
Photo 3 of 3 : UCIP_SP_2018_23888_41821.jpg

Comment Code						
Inspector Comment						
FS_ID:23888 DS_ID:21366 EP_NO: 9996 Repair Type: Non-Urgent Crossing Status: Found UCIP Comments: Need inside photo of the concrete distribution box located at the landward toe. Debris found on waterward slope (conduit running parallel to levee). This crossing is referenced in the USACE Periodic Inspection as item USACE_CESPK_MRD2_2012_p_0124. FIELD_STRUCT_DESC: 12-inch steel irrigation discharge pipe through the levee, 24 feet below the crown. Gate valve in a concrete U-shaped headwall on the waterside (WS) slope. Pump and switch house on the WS shoulder. Discharge box at the landside (LS) toe. (Retention of a 12-inch steel pipe through the levee, 24 feet below the crown, a pump, a gate valve, a switch house, and a discharge box authorized under Automatic Board Order (ABO) issued as Permit No. 9996, 1974 - Chas. F. and Nora M. Reische, et al.). [Additional Reference(s): DWR Levee Log, 2007]. FS Date: 10/22/2013

View of U-concrete headwall with positive closure device, photo 1 of 2.

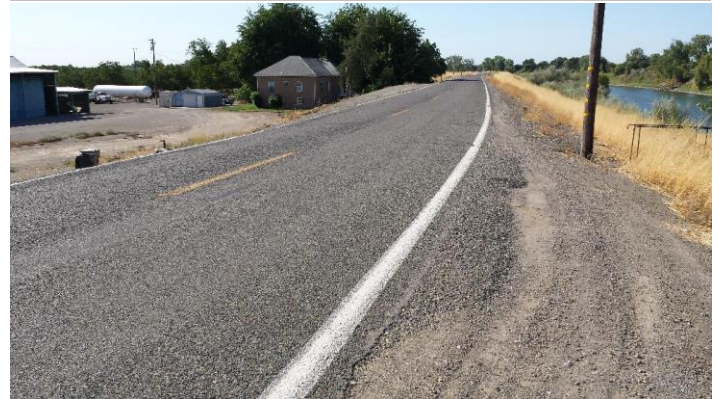
Photo 1 of 3 : UCIP_SP_2018_52551_74608.jpg

FS_ID:52551
DS_ID:21367
EP_NO: 1158
Repair Type: Urgent
Crossing Status: Found
UCIP Comments: 11/30/2017 According to DWR levee inspector, B. Duffey, the owner of the pipe did not operate pipe crossing in 2017. Owner is working with CVFPB at obtaining permit to replace pipe. (DWR UCIP - O. Magana)07/07/2016 Pipe was running during site visit. Pipe has failed internally on both the WS and LS. The scour hole on LS toe has progress and it is now about 6-feet wide by 6-feet long by 5-feet deep. Hole on WS is not visible but water is leaking underneath pipe. It appears from last inspection that the leak on the WS has also progressed. This section of the levee is known as N. Meridian Road (County Road). According to LMA representative, Andy Duffey, owner plans on submitting application for repair. Company submitting application is Davis Machine Shop contact is Thomas Davis 530-696-2576. Property owner is Steven Tarke. LMA representative contact number is 1-530-696-2569 (office) or 1-530-682-2996 (cell). Permit No. 1158 issued in 1946 lists owner as Wayne Hall. (DWR UCIP - omagana)07/28/2015 Pipe was running during site visit. Scour hole located at landward side (LS) toe is still present. New signs of stress on slope are visible on LS near concrete box. On the waterward side (WS) 2 leaks are present. The first leak is located at the pipe joint near the WS toe, the joint connection is leaking significantly. The second potential leak is near the pipe daylight on WS. Unable to confirm cause of leak but downstream seepage is present along pipe alignment. Seepage indicates that pipe may be leaking and causing internal erosion and void along pipe alignment. Recommend LMA superintendent notify owner to stop using crossing to avoid further damage to levee. Owner will need to coordinate with DWR Inspector and CVFPB to address leaky pipe per Title 23 requirements. (DWR UCIP - omagana)

View of county road where pipe crosses.

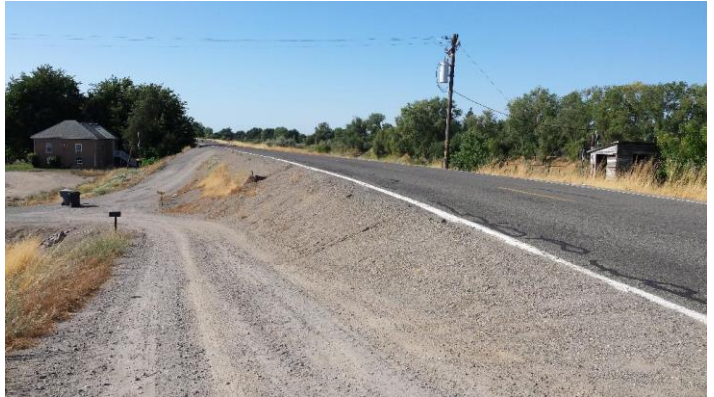
Photo 2 of 3 : UCIP_SP_2018_52551_74603.jpg

FS_ID:52551
DS_ID:21367
EP_NO: 1158
Repair Type: Urgent
Crossing Status: Found
UCIP Comments: 11/30/2017 According to DWR levee inspector, B. Duffey, the owner of the pipe did not operate pipe crossing in 2017. Owner is working with CVFPB at obtaining permit to replace pipe. (DWR UCIP - O. Magana)07/07/2016 Pipe was running during site visit. Pipe has failed internally on both the WS and LS. The scour hole on LS toe has progress and it is now about 6-feet wide by 6-feet long by 5-feet deep. Hole on WS is not visible but water is leaking underneath pipe. It appears from last inspection that the leak on the WS has also progressed. This section of the levee is known as N. Meridian Road (County Road). According to LMA representative, Andy Duffey, owner plans on submitting application for repair. Company submitting application is Davis Machine Shop contact is Thomas Davis 530-696-2576. Property owner is Steven Tarke. LMA representative contact number is 1-530-696-2569 (office) or 1-530-682-2996 (cell). Permit No. 1158 issued in 1946 lists owner as Wayne Hall. (DWR UCIP - omagana)07/28/2015 Pipe was running during site visit. Scour hole located at landward side (LS) toe is still present. New signs of stress on slope are visible on LS near concrete box. On the waterward side (WS) 2 leaks are present. The first leak is located at the pipe joint near the WS toe, the joint connection is leaking significantly. The second potential leak is near the pipe daylight on WS. Unable to confirm cause of leak but downstream seepage is present along pipe alignment. Seepage indicates that pipe may be leaking and causing internal erosion and void along pipe alignment. Recommend LMA superintendent notify owner to stop using crossing to avoid further damage to levee. Owner will need to coordinate with DWR Inspector and CVFPB to address leaky pipe per Title 23 requirements. (DWR UCIP - omagana)

View of LS and county road (N. Meridian Road).

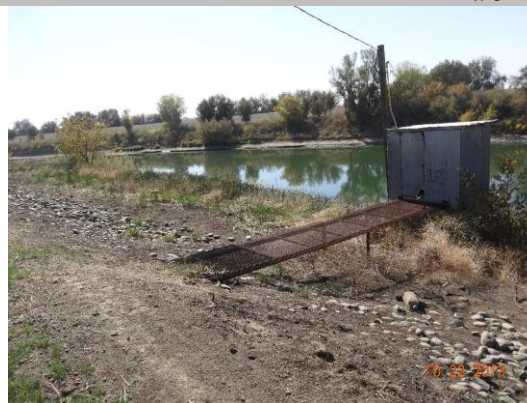
Photo 1 of 3 : UCIP_SP_2018_23891_41835.jpg

Comment Code					
Inspector Comment					
FS_ID:23891 DS_ID:21368 EP_NO: 9969 Repair Type: Non-Urgent Crossing Status: Found UCIP Comments: Landward slope too steep--need photo of the inside of concrete distribution box. Dense vegetation limits the inspector's visibility to identify signs of pipe failure (leaks) along the waterward slope. Recommend removing vegetation along pipe alignment to conduct proper inspection of structure and appurtenances. This crossing is referenced in the USACE Periodic Inspection as item USACE_CESPK_MRD2_2012_p_0158. FIELD_STRUCT_DESC: 20-inch (not 24-inch as mentioned in the permit) steel irrigation discharge pipe through the levee, 27 feet below the crown. Corrugated metal cutoff wall around the pipe at the center of the levee. Pump and gate valve in a pump house on the waterside (WS) slope. Pipe discharges into a concrete box at the landside (LS) toe. (Retention of a 24-inch steel pipe through the levee, 27 feet below the crown, a pump and gate valve, a concrete box, and a service pole authorized under Automatic Board Order (ABO) No. 9969, 1974 - Edwin J. and Vivian L. Burrows). [Additional Reference(s): DWR Levee Log, 2007. USACE Sacramento O&M Manual 134, June 1953, (Station 455+39), 24-inch listed]. FS Date: 10/22/2013

View of waterward side.

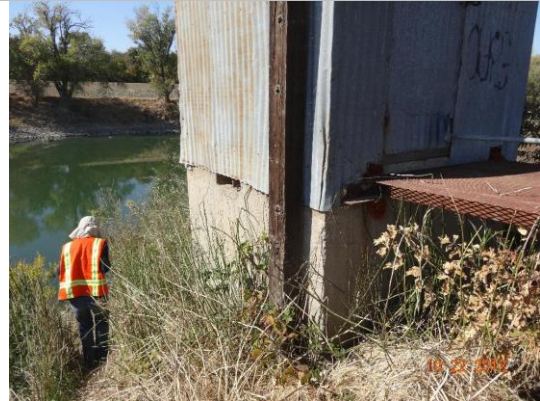
Photo 2 of 3 : UCIP_SP_2018_23891_41833.jpg

FS_ID:23891
DS_ID:21368
EP_NO: 9969
Repair Type: Non-Urgent
Crossing Status: Found
UCIP Comments: Landward slope too steep--need photo of the inside of concrete distribution box. Dense vegetation limits the inspector's visibility to identify signs of pipe failure (leaks) along the waterward slope. Recommend removing vegetation along pipe alignment to conduct proper inspection of structure and appurtenances. This crossing is referenced in the USACE Periodic Inspection as item USACE_CESPK_MRD2_2012_p_0158.
FIELD_STRUCT_DESC: 20-inch (not 24-inch as mentioned in the permit) steel irrigation discharge pipe through the levee, 27 feet below the crown. Corrugated metal cutoff wall around the pipe at the center of the levee. Pump and gate valve in a pump house on the waterside (WS) slope. Pipe discharges into a concrete box at the landside (LS) toe. (Retention of a 24-inch steel pipe through the levee, 27 feet below the crown, a pump and gate valve, a concrete box, and a service pole authorized under Automatic Board Order (ABO) No. 9969, 1974 - Edwin J. and Vivian L. Burrows). [Additional Reference(s): DWR Levee Log, 2007. USACE Sacramento O&M Manual 134, June 1953, (Station 455+39), 24-inch listed].

Pump station located on waterward side.

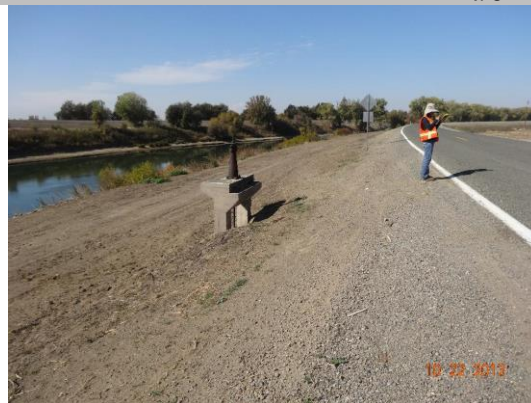
Photo 1 of 3 : UCIP_SP_2018_23892_41839.jpg

Comment Code						
Inspector Comment						
FS_ID:23892 DS_ID:21369 EP_NO: N/A Repair Type: Non-Urgent Crossing Status: Found UCIP Comments: If crossing is no longer used by owner, the owner will need to coordinate with DWR Inspector and CVFPB to remove crossing according to Title 23 requirements. Dense vegetation limits the inspector's visibility to identify signs of pipe failure (leaks) along the slope. Recommend removing vegetation along pipe alignment to conduct proper inspection of structure and appurtenances. This crossing is referenced in the USACE Periodic Inspection as item USACE_CESPK_MRD1_2012_p_0167. FIELD_STRUCT_DESC: *ABANDONED* 24-inch corrugated metal drainage pipe through the levee, 21 feet below the crown. Slide gate on the waterside (WS) end. (Cat. IVA). [Additional Reference(s): DWR Levee Log, 2007]. FS Date: 10/22/2013

View of waterward side.

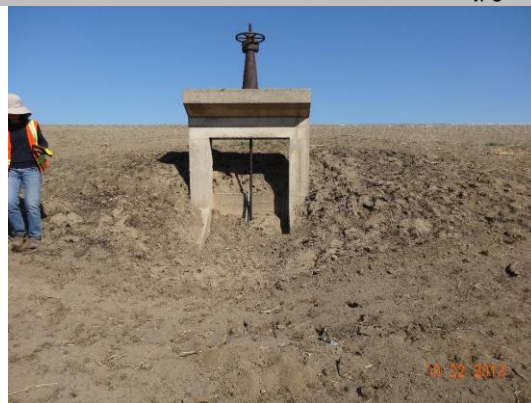
Photo 2 of 3 : UCIP_SP_2018_23892_41841.jpg

Buried screw gate located on waterward shoulder.

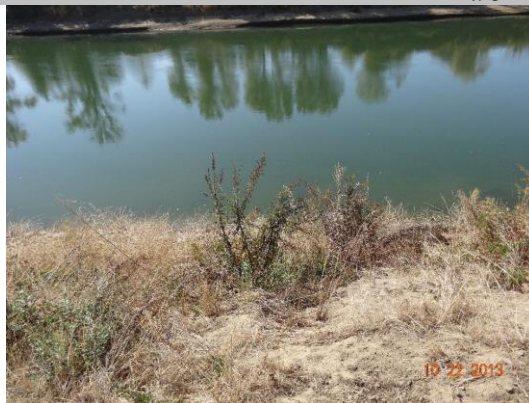
Photo 3 of 3 : UCIP_SP_2018_23892_41840.jpg

Comment Code						
Inspector Comment						
FS_ID:23892 DS_ID:21369 EP_NO: N/A Repair Type: Non-Urgent Crossing Status: Found UCIP Comments: If crossing is no longer used by owner, the owner will need to coordinate with DWR Inspector and CVFPB to remove crossing according to Title 23 requirements. Dense vegetation limits the inspector's visibility to identify signs of pipe failure (leaks) along the slope. Recommend removing vegetation along pipe alignment to conduct proper inspection of structure and appurtenances. This crossing is referenced in the USACE Periodic Inspection as item USACE_CESPK_MRD1_2012_p_0167. FIELD_STRUCT_DESC: *ABANDONED* 24-inch corrugated metal drainage pipe through the levee, 21 feet below the crown. Slide gate on the waterside (WS) end. (Cat. IVA). [Additional Reference(s): DWR Levee Log, 2007]. FS Date: 10/22/2013

Dense vegetation on the waterward edge.

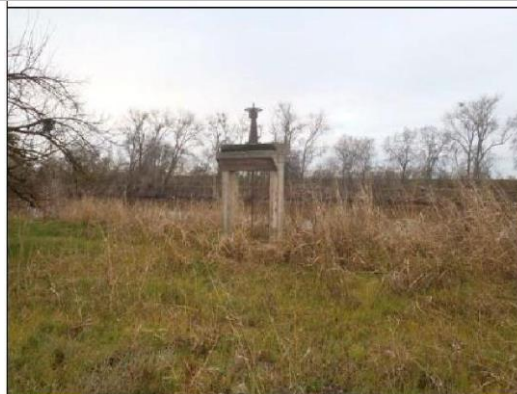
Photo 1 of 2 : UCIP_SP_2018_24115_42495.jpg

Comment Code						
Inspector Comment						
FS_ID:24115 DS_ID:21370 EP_NO: N/A Repair Type: Non-Urgent Crossing Status: Found UCIP Comments: No connection present--need to contact owner to determine if owner plans to use. If crossing is no longer in use owner will need to coordinate with DWR inspector and CVFPB to remove according to Title 23 requirements. This crossing is referenced in the USACE Periodic Inspection as USACE_CESPK_MRD2_2012_p_0197. FIELD_STRUCT_DESC: *ABANDONED* 24-inch drainage pipe of an unknown material through the levee, 18.5 feet below the crown. Slide gate on a concrete gate structure on the berm. [Additional Reference(s): DWR Levee Log, 2007]. FS Date: 10/22/2013

View of waterward side--photo is from USACE PI Report draft final issue USACE_CESPK_MRD2_2012_p_0197.

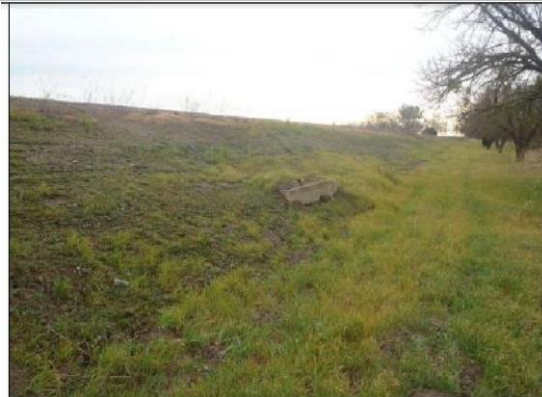
Photo 2 of 2 : UCIP_SP_2018_24115_42496.jpg

View of landward side--photo is from USACE PI Report draft final issue USACE_CESPK_MRD2_2012_p_0197.

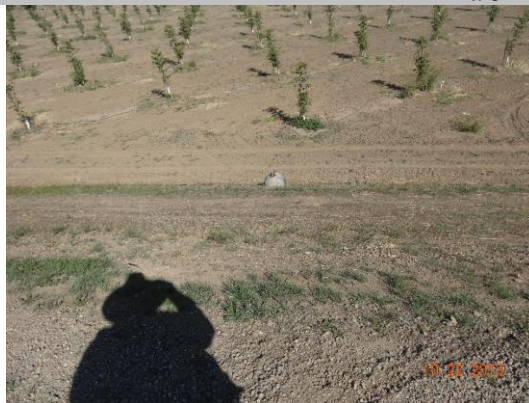
Photo 1 of 2 : UCIP_SP_2018_24117_42502.jpg

Comment Code					
Inspector Comment					
FS_ID:24117					
DS_ID:21371					
EP_NO: N/A					
Repair Type: Non-Urgent					
Crossing Status: Found					
UCIP Comments: No connection present--need to contact owner to determine if owner plans to use. If crossing is no longer in use owner will need to coordinate with DWR inspector and CVFPB to remove according to Title 23 requirements. This crossing is referenced in the USACE Periodic Inspection as USACE_CESPK_MRD2_2012_p_0197.					
FIELD_STRUCT_DESC: *ABANDONED* 24-inch drainage pipe of an unknown material through the levee, 18.5 feet below the crown. Slide gate on a concrete gate structure on the berm. [Additional Reference(s): DWR Levee Log, 2007].					
FS Date: 10/22/2013

View of pipe on landward side.

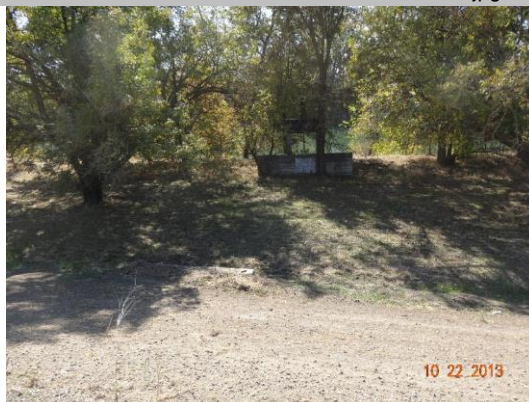
Photo 2 of 2 : UCIP_SP_2018_24117_42501.jpg

View of concrete headwall and screw gate on waterward side.

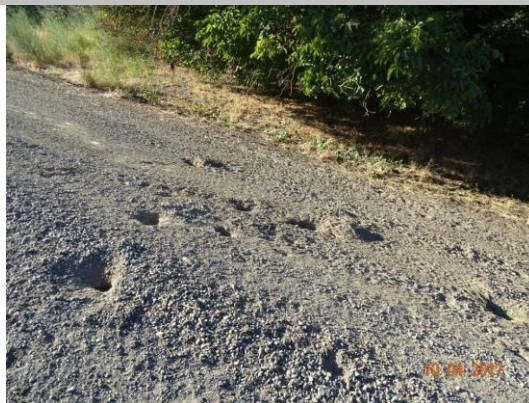
Photo 1 of 1 : SP_2018_RD0070_30_76_20180305_00019.jpg

LM Start	3.46	Rating **	M	Issue No.	76
LM End	3.46	Issue Type +	Ma	Location *	WS
Category	Earthen Levee			GPS Latitude/Longitude	
				Start	End
Item	Animal Control			39.155008 °	39.155008 °
				-121.921905 °	-121.921905 °
DWR ID	DWR_RD0070_02_f_2017_76				
Comment Code					
A1 : Exterminate rodents and backfill and compact or grout burrows.					
Inspector Comment					
Repair the rodent holes along the waterside slope.

View of the rodent holes along the waterside slope.

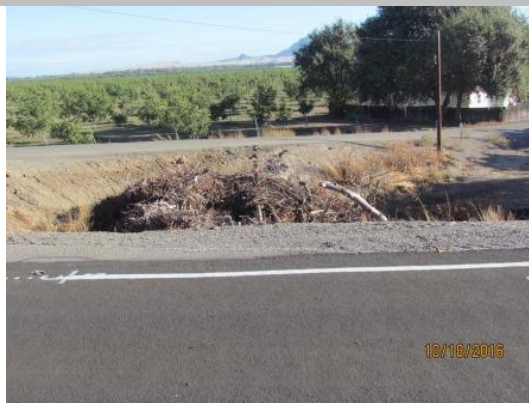
Photo 1 of 1 : SP_2018_RD0070_30_50_20180305_00004.jpg

LM Start	3.57	Rating **	M	Issue No.	50
LM End	3.57	Issue Type +	En	Location *	LS
Category	Earthen Levee			GPS Latitude/Longitude	
				Start	End
Item	Encroachments			39.154059 °	39.154059 °
				-121.920220 °	-121.920220 °
DWR ID	DWR_RD0070_02_f_2016_50				
Comment Code					
PR : Prunings					
Inspector Comment					
Remove the prunings from the landside slope.

View of the prunings along the landside toe.

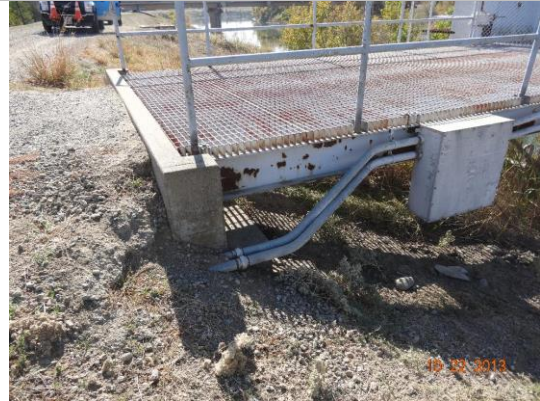
Photo 1 of 1 : UCIP_SP_2018_47028_42570.jpg

Conduits through levee along walkway.

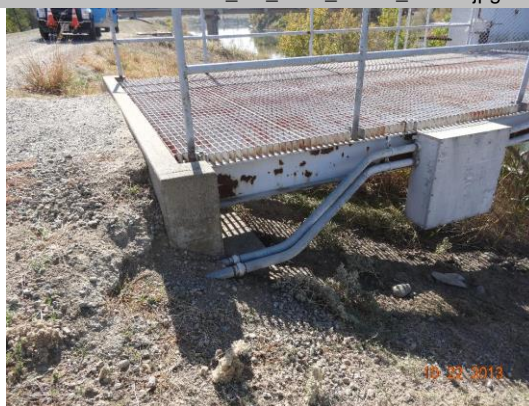
Photo 1 of 1 : UCIP_SP_2018_47029_42511.jpg

FS_ID:47029
 DS_ID:21427
 EP_NO: N/A
 Repair Type: Non-Urgent
 Crossing Status: Found
 UCIP Comments: Pump station to be removed. This record will need to be updated once the pump station is removed. This crossing is referenced in the USACE Periodic Inspection as item USACE_CESPK_MRD2_2012_p_0235.
 FIELD_STRUCT_DESC: [Meridian Farms Water Company Pumping Plant No. 2] 2 of 4: 2.5-inch steel (not iron, as mentioned in the desk study) electrical conduit through the levee, 1.9 feet below the crown. Two concrete cutoff walls, one at each shoulder. Concrete pump pit on the waterside (WS) slope. Three pumps on a structure on the WS. Walkway to the pumps. Concrete headwall on the landside (LS). Debris deflectors in the river. (Plans for construction of a pumping plant and related facilities to replace an existing plant on the left bank of the Sacramento River authorized under Permit No. 4525, 1964 - Meridian Farms Water Company. Plans for existing pumping plant to be demolished with all pipes removed and replaced with a new Meridian Diversion pumping facility, two retractable fish screens, and a 72-inch gravity feed intake pipe under the levee authorized under Permit No. 18762, 2013 - Meridian Farms Water Company). [Additional Reference(s): DWR Levee Log, 2007].

Conduits through levee along walkway.

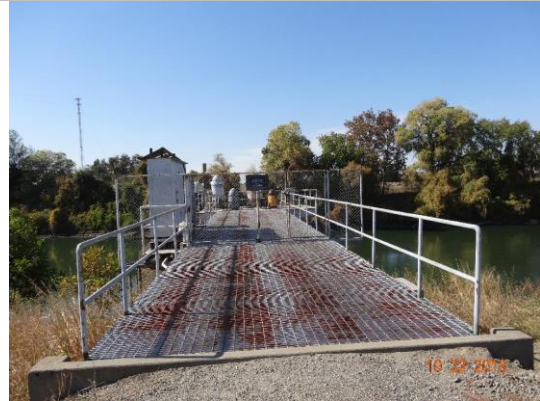
Photo 1 of 3 : UCIP_SP_2018_47030_42563.jpg

FS_ID:47030
DS_ID:21429
EP_NO: N/A
Repair Type: Non-Urgent
Crossing Status: Found
UCIP Comments: Pump is to be demolished will all pipes removed. Will need to update record. This crossing is referenced in the USACE Periodic Inspection as item USACE_CESPK_MRD2_2012_p_0235.
FIELD_STRUCT_DESC: [Meridian Farms Water Company Pumping Plant No. 1] 3 of 4: 42-inch steel irrigation discharge pipe and 2-inch polyvinyl chloride (PVC) electrical conduit through the levee, 24 and 3 feet below the crown, respectively. 42-inch pipe is concrete encased through the levee. Two concrete cutoff walls, one at each shoulder. Slide gate in a surge box on the waterside (WS). Concrete pump pit on the WS slope. Three pumps on a structure on the WS. Walkway to the pumps with an electrical control box. Concrete headwall on the landside (LS). Pipe discharges into a concrete lined irrigation ditch on the LS. Debris deflectors in the river. Power poles on the LS. (Plans to enlarge the Meridian Farms Water Company Pump Station Facility No. 1 by adding a 150-horsepower pump, a 42-inch water pipe, and a 2-inch electrical conduit through the levee authorized under Permit No. 13380, 1982 - Meridian Farms Water Company. Plans for existing pumping plant to be demolished with all pipes removed and replaced with a new Meridian Diversion pumping facility, two retractable fish screens, and a 72-inch gravity feed intake pipe under the levee authorized under Permit No. 18762, 2013 - Meridian Farms Water Company). [Additional Reference(s): DWR Levee Log, 2007].

View of walkway and pump station on waterward side.

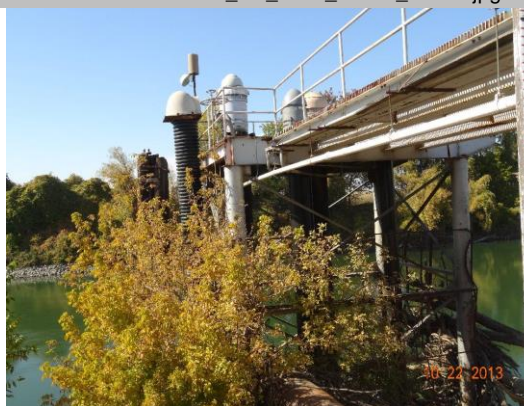
Photo 3 of 3 : UCIP_SP_2018_47030_42569.jpg

FS_ID:47030
DS_ID:21429
EP_NO: N/A
Repair Type: Non-Urgent
Crossing Status: Found
UCIP Comments: Pump is to be demolished will all pipes removed. Will need to update record. This crossing is referenced in the USACE Periodic Inspection as item USACE_CESPK_MRD2_2012_p_0235.
FIELD_STRUCT_DESC: [Meridian Farms Water Company Pumping Plant No. 1] 3 of 4: 42-inch steel irrigation discharge pipe and 2-inch polyvinyl chloride (PVC) electrical conduit through the levee, 24 and 3 feet below the crown, respectively. 42-inch pipe is concrete encased through the levee. Two concrete cutoff walls, one at each shoulder. Slide gate in a surge box on the waterside (WS). Concrete pump pit on the WS slope. Three pumps on a structure on the WS. Walkway to the pumps with an electrical control box. Concrete headwall on the landside (LS). Pipe discharges into a concrete lined irrigation ditch on the LS. Debris deflectors in the river. Power poles on the LS. (Plans to enlarge the Meridian Farms Water Company Pump Station Facility No. 1 by adding a 150-horsepower pump, a 42-inch water pipe, and a 2-inch electrical conduit through the levee authorized under Permit No. 13380, 1982 - Meridian Farms Water Company. Plans for existing pumping plant to be demolished with all pipes removed and replaced with a new Meridian Diversion pumping facility, two retractable fish screens, and a 72-inch gravity feed intake pipe under the levee authorized under Permit No. 18762, 2013 - Meridian Farms Water Company). [Additional Reference(s): DWR Levee Log, 2007].

View of pumps located on waterward side.

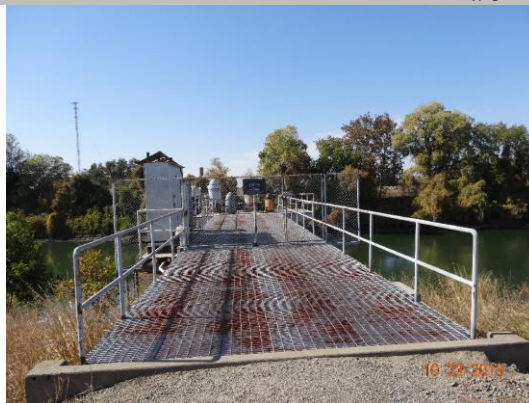
Photo 1 of 3 : UCIP_SP_2018_47032_42076.jpg

FS_ID:47032
DS_ID:21373
EP_NO: N/A
Repair Type: Non-Urgent
Crossing Status: Indicator Found
UCIP Comments: Unable to confirm 54-inch pipe only found 42-inch pipe. Pump station is to be removed. Need to update record once crossing has been modified. This crossing is referenced in the USACE Periodic Inspection as item USACE_CESPK_MRD2_2012_p_0235.
FIELD_STRUCT_DESC: [Meridian Farms Water Company Pumping Plant No. 2] 4 of 4: 54-inch steel irrigation discharge pipe through the levee, 24 feet below the crown. Pipe is concrete encased through the levee. Two concrete cutoff walls, one at each shoulder. Slide gate in a surge box on the waterside (WS). Concrete pump pit on the WS slope. Three pumps on a structure on the WS. Walkway to the pumps. Concrete headwall on the landside (LS). Pipe discharges into a concrete lined irrigation ditch on the LS. Debris deflectors in the river. (Plans for construction of a pumping plant and related facilities to replace an existing plant on the left bank of the Sacramento River authorized under Permit No. 4525, 1964 - Meridian Farms Water Company. Plans for existing pumping plant to be demolished with all pipes removed and replaced with a new Meridian Diversion pumping facility, two retractable fish screens, and a 72-inch gravity feed intake pipe under the levee authorized under Permit No. 18762, 2013 - Meridian Farms Water Company). [Additional Reference(s): DWR Levee Log, 2007].

View of walkway and pump station on waterward side.

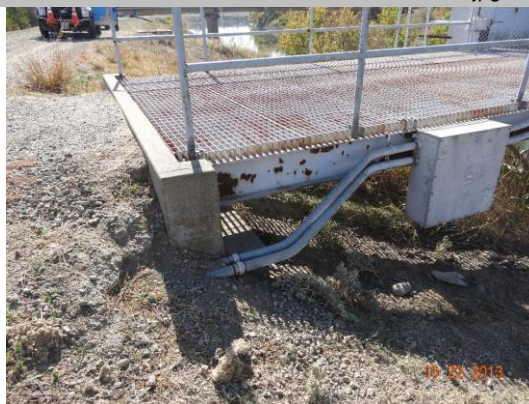
Photo 2 of 3 : UCIP_SP_2018_47032_42080.jpg

View of conduit pipes through levee.

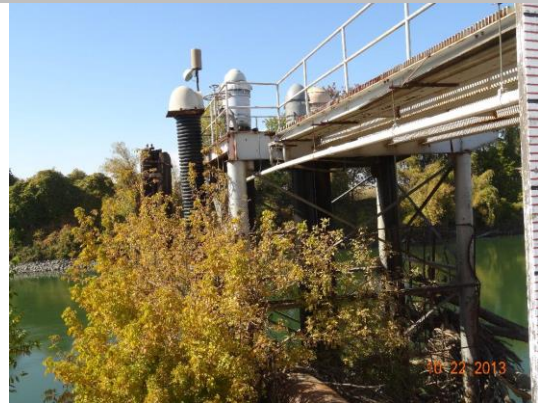
Photo 3 of 3 : UCIP_SP_2018_47032_42082.jpg

FS_ID:47032
DS_ID:21373
EP_NO: N/A
Repair Type: Non-Urgent
Crossing Status: Indicator Found
UCIP Comments: Unable to confirm 54-inch pipe only found 42-inch pipe. Pump station is to be removed. Need to update record once crossing has been modified. This crossing is referenced in the USACE Periodic Inspection as item USACE_CESPK_MRD2_2012_p_0235.
FIELD_STRUCT_DESC: [Meridian Farms Water Company Pumping Plant No. 2] 4 of 4: 54-inch steel irrigation discharge pipe through the levee, 24 feet below the crown. Pipe is concrete encased through the levee. Two concrete cutoff walls, one at each shoulder. Slide gate in a surge box on the waterside (WS). Concrete pump pit on the WS slope. Three pumps on a structure on the WS. Walkway to the pumps. Concrete headwall on the landside (LS). Pipe discharges into a concrete lined irrigation ditch on the LS. Debris deflectors in the river. (Plans for construction of a pumping plant and related facilities to replace an existing plant on the left bank of the Sacramento River authorized under Permit No. 4525, 1964 - Meridian Farms Water Company. Plans for existing pumping plant to be demolished with all pipes removed and replaced with a new Meridian Diversion pumping facility, two retractable fish screens, and a 72-inch gravity feed intake pipe under the levee authorized under Permit No. 18762, 2013 - Meridian Farms Water Company). [Additional Reference(s): DWR Levee Log, 2007].

View of pumps located on waterward side.

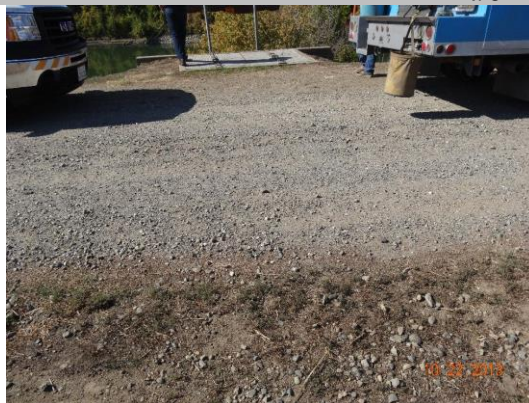
Photo 1 of 3 : UCIP_SP_2018_24165_42573.jpg

Comment Code					
Inspector Comment					
FS_ID:24165 DS_ID:21374 EP_NO: 767 Repair Type: Non-Urgent Crossing Status: Found UCIP Comments: Need to contact owner to determine if crossing is still active and to determine last inspection date. Will need copy of letter showing crossings passed inspection. This crossing is referenced in the USACE Periodic Inspection as item USACE_CESPK_MRD2_2012_p_0237. FIELD_STRUCT_DESC: 3-inch steel natural gas pipeline (not 3.5-inch, as mentioned in the desk study) through the levee, 3 feet below the crown. 8-foot by 10-foot by 1-foot concrete inspection well with a metal cover on the waterside (WS) shoulder. Rock revetment on the WS slope. Painted aluminum marker on the WS. Contact information provided on marker: (916) 742-7344 and for emergencies call (916) 742-3251. (Plans for the construction of a natural gas pipeline across the Sacramento River and the east and west levees thereof authorized under Permit No. 767, 1938 - Pacific Gas and Electric Company [PG&E]). [Additional Reference(s): DWR Levee Log, 2007]. FS Date: 10/22/2013

View of levee crown.

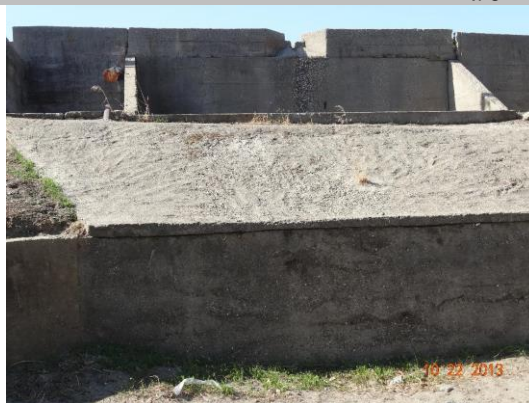
Photo 1 of 1 : UCIP_SP_2018_23959_42096.jpg

Comment Code					
Inspector Comment					
FS_ID:23959 DS_ID:21375 EP_NO: 1123 Repair Type: Non-Urgent Crossing Status: Indicator Found UCIP Comments: No connection present. If crossing is no longer in use owner will need to coordinate with DWR inspector and CVFPB to remove according to Title 23 requirements. This crossing is referenced in the USACE Periodic Inspection as item USACE_CESPK_MRD2_2012_p_0240. FIELD_STRUCT_DESC: 1 of 3: 10-inch water supply pipe of an unknown material through the levee, 2 feet below the crown. Seed washing plant with concrete catch basin and pan on the landside (LS) slope. Concrete sump on the waterside (WS) slope. Intake pump on the WS slope. (Plans for installing a seed washer on the LS slope and influent and effluent pipes through the levee authorized under Permit No. 1123, 1946 - G. J. Reitter). [Additional Reference(s): DWR Levee Log, 2007. USACE Sacramento O&M Manual 134, June 1953, (Station 496+25)]. FS Date: 10/22/2013

Concrete headwall located on landward side--no pipe. Only visible pipe is the pipe located at the far left (downstream end).

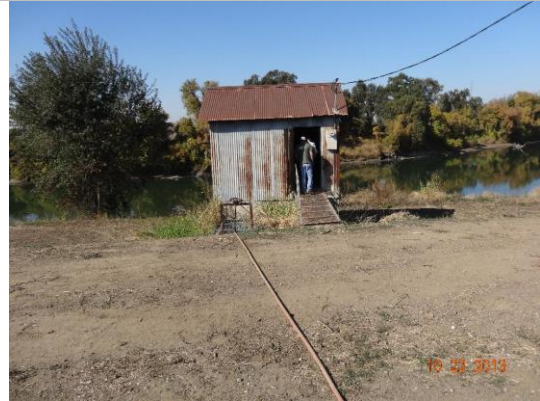
Photo 1 of 3 : UCIP_SP_2018_23962_42099.jpg

FS_ID:23962
DS_ID:21379
EP_NO: 9998
Repair Type: Non-Urgent
Crossing Status: Found
UCIP Comments: Unable to confirm if crossing corresponds to permit 9998. Pipe size is different then the pipe size listed in the desk study. Unable to confirm if structure on landward side is a pump house. Need to coordinate with owner to obtain permit record for crossing. Need to verify status of crossing. Permit authorized 24 inch pipe. Pipe through levee is 30 inches. Unable to find stand pipe in field. Dense vegetation limits the inspector's visibility to identify signs of pipe failure (leaks) along the slope. Recommend removing vegetation along pipe alignment to conduct proper inspection of structure and appurtenances. This crossing is referenced in the USACE Periodic Inspection as item USACE_CESPK_MRD2_2012_p_0264.
FIELD_STRUCT_DESC: 30-inch (not 24-inch as indicated in desk study) corrugated metal irrigation discharge pipe through the levee, 15.5 feet below the crown. Slide gate in a concrete distribution box at the landside (LS) toe. Pump in a pump house on the LS. Service pole and ramp on the waterside (WS) slope. Concrete box with air vents on the WS end. (Retention of a 24-inch corrugated metal pipe (CMP) through the levee, 15.5 feet below the crown, a pump, a slide gate, a service pole, and a concrete distribution box authorized under Automatic Board Order (ABO) issued as Permit No. 9998, 1974 - Robert Tod Ruse, Trustee. Plans to install an 18-inch polyvinyl chloride (PVC) pipe through an existing 24-inch steel pipe under the levee with annular space grouted authorized under Permit No. 16228, 1994 - Mike and Carol Churkin). [Additional Reference(s): DWR Levee Log, 2007. USACE Sacramento O&M Manual 134, June 1953, (Station 516+06)].

View of pump house located on waterward side.

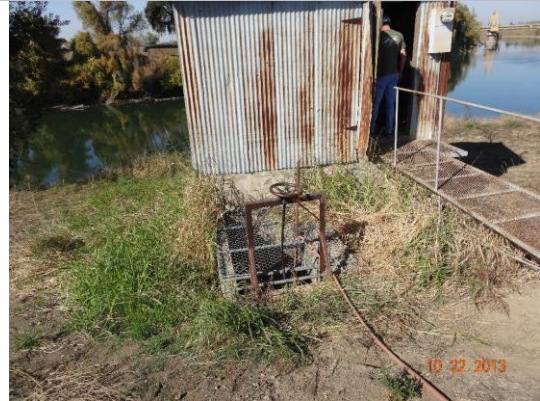
Photo 2 of 3 : UCIP_SP_2018_23962_42104.jpg

Comment Code						
Inspector Comment						
FS_ID:23962 DS_ID:21379 EP_NO: 9998 Repair Type: Non-Urgent Crossing Status: Found UCIP Comments: Unable to confirm if crossing corresponds to permit 9998. Pipe size is different then the pipe size listed in the desk study. Unable to confirm if structure on landward side is a pump house. Need to coordinate with owner to obtain permit record for crossing. Need to verify status of crossing. Permit authorized 24 inch pipe. Pipe through levee is 30 inches. Unable to find stand pipe in field. Dense vegetation limits the inspector's visibility to identify signs of pipe failure (leaks) along the slope. Recommend removing vegetation along pipe alignment to conduct proper inspection of structure and appurtenances. This crossing is referenced in the USACE Periodic Inspection as item USACE_CESPK_MRD2_2012_p_0264. FIELD_STRUCT_DESC: 30-inch (not 24-inch as indicated in desk study) corrugated metal irrigation discharge pipe through the levee, 15.5 feet below the crown. Slide gate in a concrete distribution box at the landside (LS) toe. Pump in a pump house on the LS. Service pole and ramp on the waterside (WS) slope. Concrete box with air vents on the WS end. (Retention of a 24-inch corrugated metal pipe (CMP) through the levee, 15.5 feet below the crown, a pump, a slide gate, a service pole, and a concrete distribution box authorized under Automatic Board Order (ABO) issued as Permit No. 9998, 1974 - Robert Tod Ruse, Trustee. Plans to install an 18-inch polyvinyl chloride (PVC) pipe through an existing 24-inch steel pipe under the levee with annular space grouted authorized under Permit No. 16228, 1994 - Mike and Carol Churkin). [Additional Reference(s): DWR Levee Log, 2007. USACE Sacramento O&M Manual 134, June 1953, (Station 516+06)]. FS Date: 10/22/2013

Positive closure device located at the waterward side inside concrete distribution box.

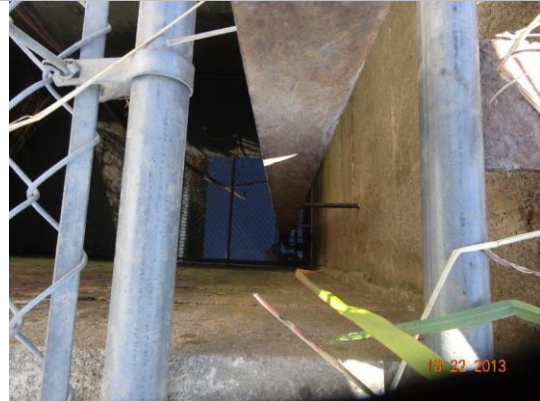
Photo 3 of 3 : UCIP_SP_2018_23962_42101.jpg

FS_ID:23962
DS_ID:21379
EP_NO: 9998
Repair Type: Non-Urgent
Crossing Status: Found
UCIP Comments: Unable to confirm if crossing corresponds to permit 9998. Pipe size is different then the pipe size listed in the desk study. Unable to confirm if structure on landward side is a pump house. Need to coordinate with owner to obtain permit record for crossing. Need to verify status of crossing. Permit authorized 24 inch pipe. Pipe through levee is 30 inches. Unable to find stand pipe in field. Dense vegetation limits the inspector's visibility to identify signs of pipe failure (leaks) along the slope. Recommend removing vegetation along pipe alignment to conduct proper inspection of structure and appurtenances. This crossing is referenced in the USACE Periodic Inspection as item USACE_CESPK_MRD2_2012_p_0264.
FIELD_STRUCT_DESC: 30-inch (not 24-inch as indicated in desk study) corrugated metal irrigation discharge pipe through the levee, 15.5 feet below the crown. Slide gate in a concrete distribution box at the landside (LS) toe. Pump in a pump house on the LS. Service pole and ramp on the waterside (WS) slope. Concrete box with air vents on the WS end. (Retention of a 24-inch corrugated metal pipe (CMP) through the levee, 15.5 feet below the crown, a pump, a slide gate, a service pole, and a concrete distribution box authorized under Automatic Board Order (ABO) issued as Permit No. 9998, 1974 - Robert Tod Ruse, Trustee. Plans to install an 18-inch polyvinyl chloride (PVC) pipe through an existing 24-inch steel pipe under the levee with annular space grouted authorized under Permit No. 16228, 1994 - Mike and Carol Churkin). [Additional Reference(s): DWR Levee Log, 2007. USACE Sacramento O&M Manual 134, June 1953, (Station 516+06)].

Photo of the concrete distribution box located on waterward side.

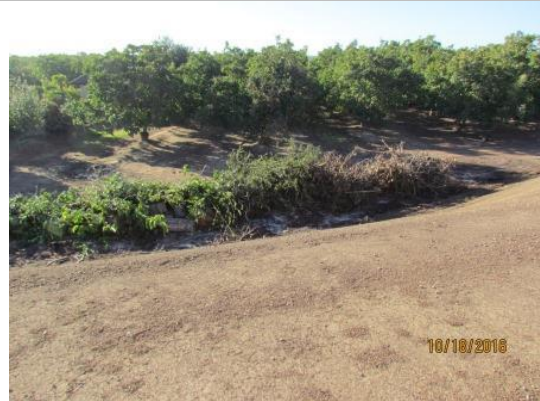
Photo 1 of 1 : SP_2018_RD0070_30_53_20180305_00005.jpg

LM Start	4.59	Rating **	M	Issue No.	53
LM End	4.59	Issue Type +	En	Location *	LS
Category	Earthen Levee			GPS Latitude/Longitude	
				Start	End
Item	Encroachments			39.140975 °	39.140975 °
				-121.919907 °	-121.919907 °
DWR ID	DWR_RD0070_02_f _ 2016_53				
Comment Code					
PR : Prunings					
Inspector Comment					
Remove prunings from the landside toe.

View of the prunings along the landside toe.

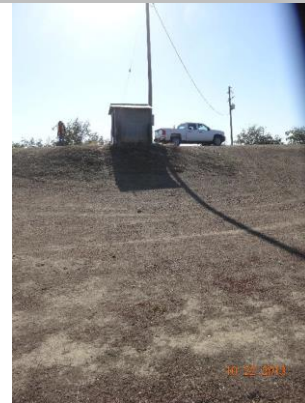
Photo 1 of 3 : UCIP_SP_2018_24166_42581.jpg

Comment Code						
Inspector Comment						
FS_ID:24166 DS_ID:21380 EP_NO: 9970 Repair Type: Non-Urgent Crossing Status: Found UCIP Comments: Need to coordinate with owner to determine status of crossing. No pump is located inside the pump house located on waterward side. If crossing is no longer in use owner will need to contact the CVFPB to comply with Title 23. Dense vegetation limits the inspector's visibility to identify signs of pipe failure (leaks) along the slope. Recommend removing vegetation along pipe alignment to conduct proper inspection of structure and appurtenances. This crossing is referenced in the USACE Periodic Inspection as item USACE_CESPK_MRD2_2012_p_0274. FIELD_STRUCT_DESC: 10-inch steel irrigation discharge pipe through the levee, 4.8 feet below the crown. Corrugated metal cutoff wall around the pipe at the center of the levee. Siphon breaker on the landside (LS) slope, not found. Pump in a pump house on the waterside (WS) shoulder. Shutoff valve on the LS. Concrete discharge box at the LS toe. (Retention of a 10-inch steel pipe through the levee, 4.8 feet below the crown, a pump, a service pole, a siphon breaker, and a concrete discharge box authorized under Automatic Board Order (ABO) issued as Permit No. 9970, 1974 - Arnold Chesini). [Additional Reference(s): DWR Levee Log, 2007. USACE Sacramento O&M Manual 134, June 1953, (Station 526+71)]. FS Date: 10/22/2013

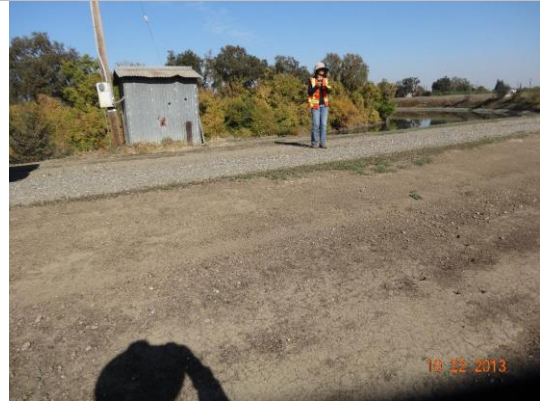
Photo 2 of 3 : UCIP_SP_2018_24166_42580.jpg

UCIP Comments: Need to coordinate with owner to determine status of crossing. No pump is located inside the pump house located on waterward side. If crossing is no longer in use owner will need to contact the CVFPB to comply with Title 23. Dense vegetation limits the inspector's visibility to identify signs of pipe failure (leaks) along the slope. Recommend removing vegetation along pipe alignment to conduct proper inspection of structure and appurtenances. This crossing is referenced in the USACE Periodic Inspection as item USACE_CESPK_MRD2_2012_p_0274.

View of levee crown and pump house photo taken from landward side.

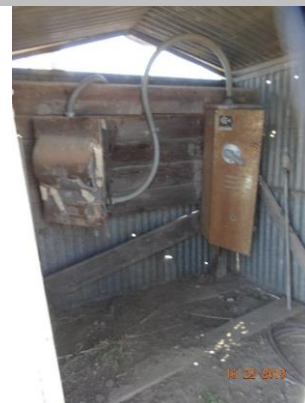
Photo 3 of 3 : UCIP_SP_2018_24166_42583.jpg

View of the inside of pump house--no pump.

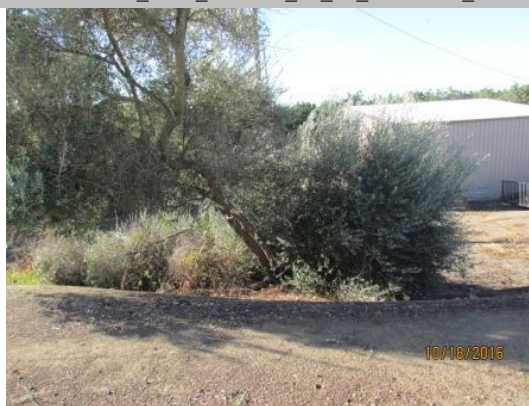
Photo 1 of 1 : SP_2018_RD0070_30_54_20180305_00006.jpg

LM Start	4.95	Rating **	M	Issue No.	54
LM End	4.95	Issue Type +	Ma	Location *	LS
Category	Earthen Levee			GPS Latitude/Longitude	
				Start	End
Item	Trim / Thin Trees			39.142016 °	39.142016 °
				-121.926214 °	-121.926214 °
DWR ID	DWR_RD0070_02_f_2016_54				
Comment Code					
T1 : Trim trees to at least five feet above ground level.					
Inspector Comment

View of the trees blocking visibility.

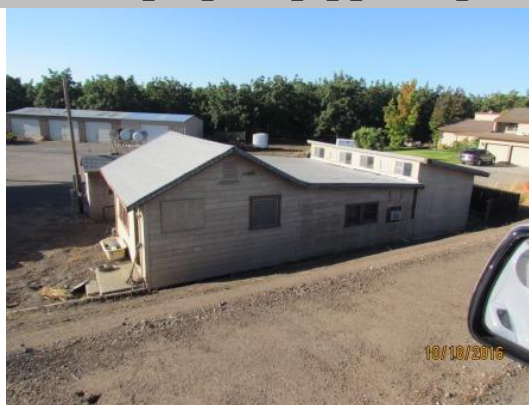
Photo 1 of 1 : SP_2018_RD0070_30_9_20180305_00003.jpg

LM Start	4.95	Rating **	U	Issue No.	9
LM End	4.98	Issue Type +	En	Location *	LS
Category	Earthen Levee			GPS Latitude/Longitude	
				Start	End
Item	Encroachments			39.142008 °	39.142032 °
				-121.926267 °	-121.926855 °
DWR ID	DWR_RD0070_02_s_2012_9				
Comment Code					
BU : Building					
Inspector Comment

View of a building within the easement of the levee.

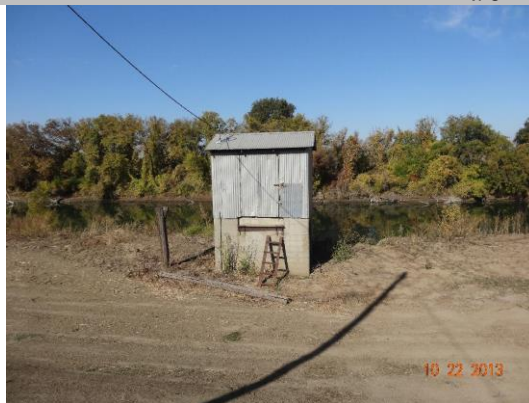
Photo 1 of 3 : UCIP_SP_2018_23964_42114.jpg

Comment Code						
Inspector Comment						
FS_ID:23964 DS_ID:21383 EP_NO: 9984 Repair Type: Non-Urgent Crossing Status: Found UCIP Comments: Will need to contact owner. Need to obtain maintenance records and clarify modifications made at to crossing (size). Additional crossing visible through concrete headwall on landward side--crossing has been capped (see photo). NEED TO CONFIRM PIPE SIZE!!! This crossing is referenced in the USACE Periodic Inspection as item USACE_CESPK_MRD2_2012_p_0289. FIELD_STRUCT_DESC: 12-inch steel irrigation discharge pipe (not 24-inch, as referenced in the permit) through the levee, 13.8 feet below the crown. Gate valve on the waterside (WS). Pump in a pump house on the WS. Concrete distribution box at the landside (LS) toe. (Retention of a 24-inch steel pipe through the levee, 13.8 feet below the crown, a pump, a gate valve, and a concrete distribution box authorized under Automatic Board Order (ABO) issued as Permit No. 9984, 1974 - Edward E. and Alice B. Lemos, et al.). [Additional Reference(s): DWR Levee Log, 2007. USACE Sacramento O&M Manual 134, June 1953, (Station 555+09), 24-inch listed]. FS Date: 10/22/2013

Pump house located on waterward side.

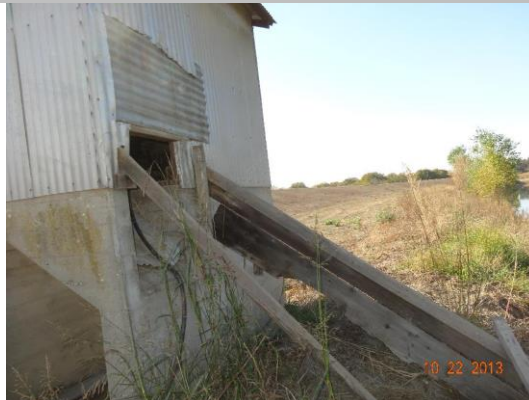
Photo 2 of 3 : UCIP_SP_2018_23964_42116.jpg

No pipe exists the pump house on waterward side.

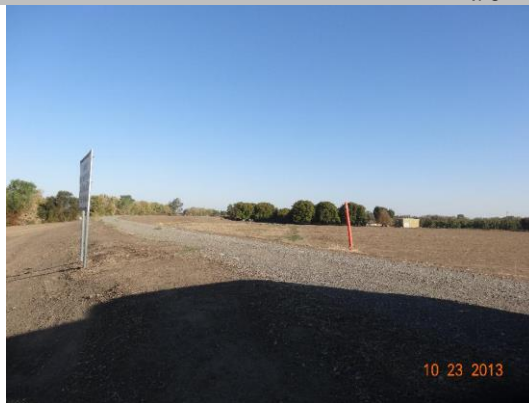
Photo 1 of 3 : UCIP_SP_2018_23965_42123.jpg

FS_ID:23965
DS_ID:21385
EP_NO: 4383
Repair Type: Non-Urgent
Crossing Status: Found
UCIP Comments: Need to contact owner to determine if crossing is still active and to determine last inspection date. Will need copy of letter showing crossings passed inspection. This crossing is referenced in the USACE Periodic Inspection as item USACE_CESPK_MRD2_2012_p_0319.
FIELD_STRUCT_DESC: 8.625-inch steel natural gas pipeline through the levee, 3.5 feet below the crown. Concrete cutoff wall around the pipe at the center of the levee. Rock revetment on the waterside (WS) slope. (Plans for construction, maintenance, and use of an 8.625-inch gas line authorized under Permit No. 4383, 1963 - Pacific Gas and Electric Company [PG&E]). [Additional Reference(s): DWR Levee Log, 2007].
FS Date: 10/23/2013

Markers visible on both levee shoulders.

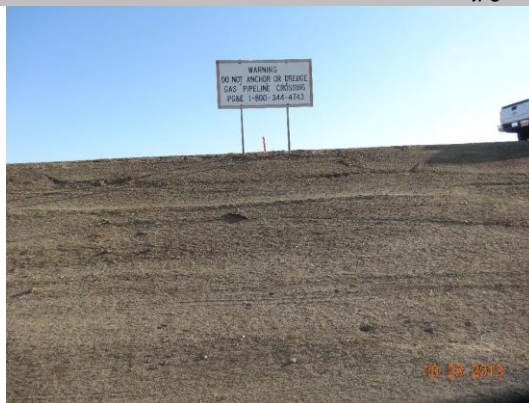
Photo 2 of 3 : UCIP_SP_2018_23965_42121.jpg

View of waterward slope.

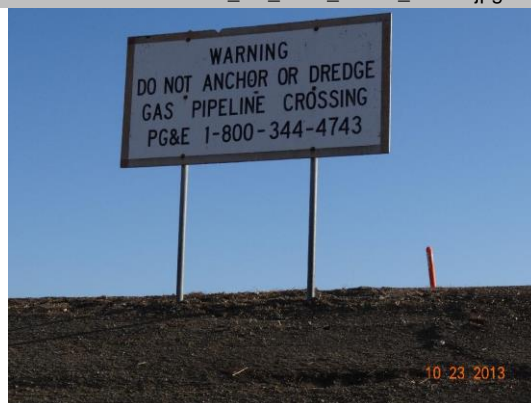
Photo 3 of 3 : UCIP_SP_2018_23965_42122.jpg

Comment Code						
Inspector Comment						
FS_ID:23965 DS_ID:21385 EP_NO: 4383 Repair Type: Non-Urgent Crossing Status: Found UCIP Comments: Need to contact owner to determine if crossing is still active and to determine last inspection date. Will need copy of letter showing crossings passed inspection. This crossing is referenced in the USACE Periodic Inspection as item USACE_CESPK_MRD2_2012_p_0319. FIELD_STRUCT_DESC: 8.625-inch steel natural gas pipeline through the levee, 3.5 feet below the crown. Concrete cutoff wall around the pipe at the center of the levee. Rock revetment on the waterside (WS) slope. (Plans for construction, maintenance, and use of an 8.625-inch gas line authorized under Permit No. 4383, 1963 - Pacific Gas and Electric Company [PG&E]). [Additional Reference(s): DWR Levee Log, 2007]. FS Date: 10/23/2013

Sign visible on waterward side.

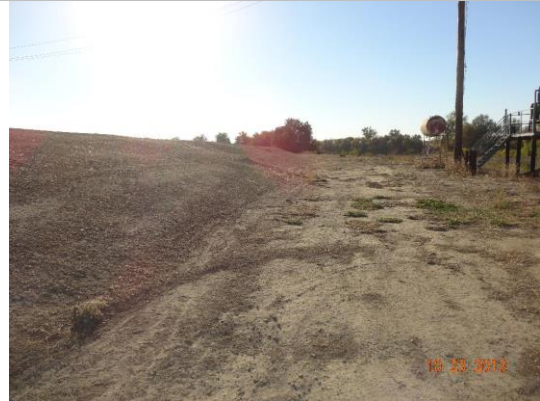
Photo 1 of 3 : UCIP_SP_2018_46424_42043.jpg

FS_ID:46424
DS_ID:21386
EP_NO: 9994
Repair Type: Non-Urgent
Crossing Status: Found
UCIP Comments: 07/28/2015 System was running during site visit. Damage to landward side has been repaired. No records available to determine cause of erosion--monitor. No other issues observed during site visit. 10/23/2013 Erosion visible on landward side behind concrete headwall. Plastic sheeting has been placed to protect slope. Need to determine cause for erosion, is pipe leaking? Pipe wall on landward side has deteriorated significantly that the wall is gone. Owner will need to coordinate with DWR inspector and CVFPB to address issue. Recommend notifying owner to stop using crossing until issue has been addressed. This crossing is referenced in the USACE Periodic Inspection as item USACE_CESPK_MRD2_2012_p_0324.
FIELD_STRUCT_DESC: 20-inch coated steel irrigation discharge pipe on the waterside (WS) and 24-inch coated steel irrigation discharge pipe on the landside (LS) through the levee, 12.5 feet below the crown. Pipe is concrete encased under the crown, between the shoulders. Slide gate in a metal well on the WS slope. Pump on a pile structure in the stream. Concrete discharge box at the LS toe. Service pole on the WS slope. (Plans for the installation of an irrigation pumping plant and appurtenant electrical power line across the levee authorized under Permit No. 1202, 19 - Hannah R. Jacobs. Retention of a 24-inch concrete encased steel pipe through the levee, 12.5 feet below the crown, a pump, a slide gate, and a concrete discharge box authorized under Automatic Board Order (ABO) issued as Permit No. 9994, 1974 - R. X. Ranch Company). [Additional Reference(s): DWR Levee Log, 2007. USACE Sacramento O&M Manual 134, June 1953, (Station 610+84)].

View of levee slope and berm on waterward side.
